Harwood's Rail Heritage

A Brief History in Four Parts

Part 3. The Rice Lake Bridge

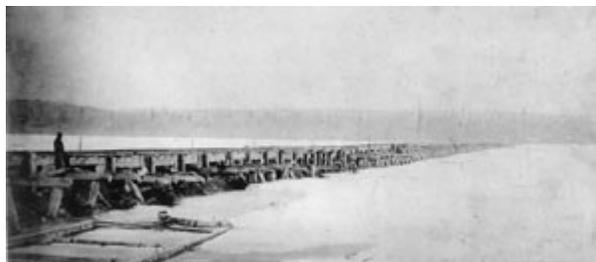
From Harwood, a pile trestle bridge 3,754 feet in length would be constructed north to Tic Island.

The Rice Lake Bridge showing the trestles used

North of Tic Island a succession of 10 by 20 foot wooden cribs would extend a distance of 2,760 feet, each crib at 80 foot centres from each other. These cribs, filled with stones, would support seventeen Burr Truss Bridge spans. The last eight of these were to be built on a slight incline to a Pivot swing bridge supported on a 20 by 40 foot pier to provide tow openings of fifty feet each. This was followed by another series of 8 Burr Truss Bridges on a decline similarly laid on cribs. A final pile trestle, 6,728 feet long ended on the north shore of Rice Lake at Indian Village (Hiawatha).

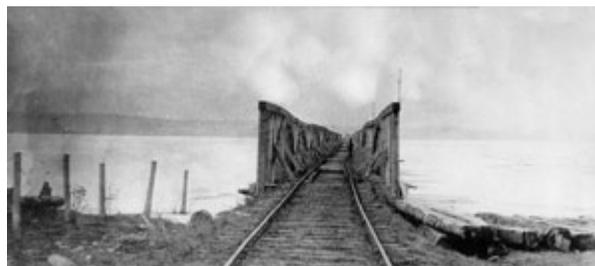
Rice Lake Bridge - probably taken after being damaged.

The bridge was but shortly in use. On January 1, 1855, ice served notice to Rice Lake Bridge that it was a force with which to contend. Weather conspired to create a condition whereby ice proved stronger than the bridge anchors. The northern portion of the trestle suffered some movement but that damage was slight by comparison to other sections of the structure. The southern seventeen Burr Truss bridges were forced towards Tic Island with such force that the last span slid four feet upon the solid embankment. South of Tic Island the pile bridge was shoved towards the south shore with such force that 12 by 18 inch oak stringers were splintered that action bending the iron rails double. Only a small portion of the trestle remain in place. As the bridge was being repaired, it was discovered that the contractors had not filled in with stone some of the cribs which may have stabilized these foundations and prevented the bridge spans from shifting.

one of the Port Hope men. Be that as it may, a portion of the bridge was removed by winter ice and floated away to the east and drifted to a place the southern shore. That breach terminated rail service north to Peterborough and proved to be the end of such service. Over subsequent decades other parts of the bridge superstructure were damaged and it was never rebuilt.
